REVISITING THE TIMING AND EVENTS
LEADING TO AND CAUSING THE
JOHNSTOWN FLOOD OF 1889

*Uldis Kaktins, Carrie Davis Todd,
Stephanie Wojno, and Neil Coleman*

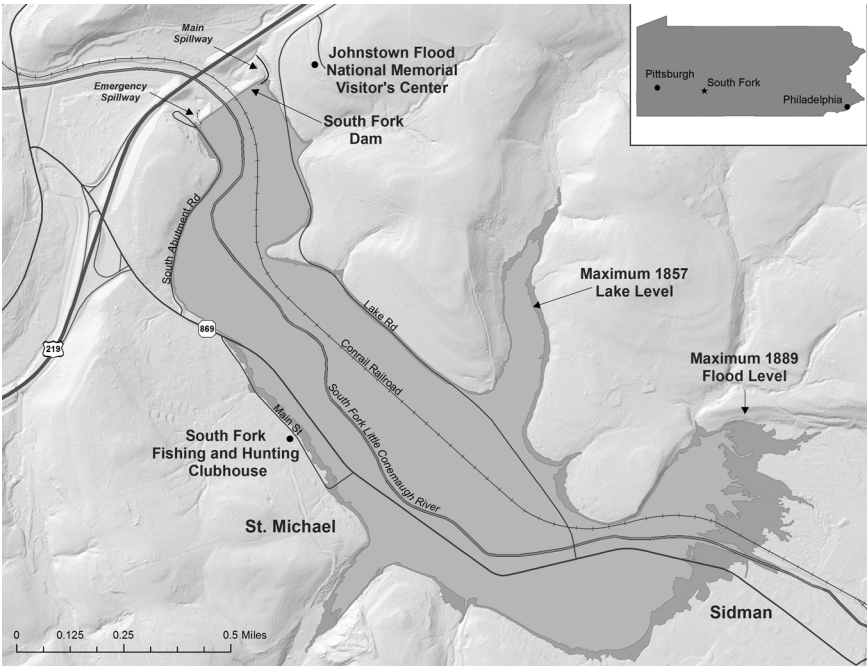
given in the 1891 report by James B. Francis and others.⁷ Our analysis using GIS software (ArcGIS 10) shows that at the moment the dam breached in 1889, the impoundment held about 495 million cubic feet of water (or about 15.5 million tons) below a contour elevation of 1,615 feet, which we find approximates the modern elevation of the impounded lake water at failure. The calculated tonnage is almost 5 million tons less than the usually cited figure of 20 million tons. Our work with modern LiDAR data (1-meter resolution) updates previous results by the National Park Service, which used an older digital elevation model (10-meter resolution), to estimate a lake volume of 449 million cubic feet of water when the dam failed.⁸ The older 10-meter digital elevation model used lower-quality data that was primarily derived by digitizing contours from U.S. Geological Survey 7.5-minute topographic quadrangle maps.

FIGURE 2: Overhead view of the former Lake Conemaugh, superimposed on a relief map with present-day features that include a railway through the dam breach, Highway 219, and the park visitors' center. The areal extent of the lake is shown for two different times: normal pool level of 1,609 feet in 1857, when the dam was acquired by the Pennsylvania Railroad, and later, at maximum flood level (1,615 feet) when the dam breached in 1889. Image prepared by authors for this article. Google Earth image. Software available at <http://www.google.com/earth/index.html>.

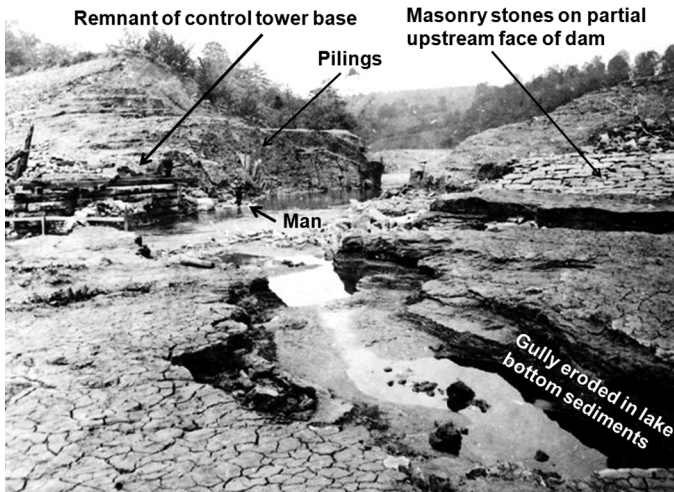
The modern lake volumes represent upper limits because lake-bottom sediments were present at the time of the 1889 flood (see fig. 3). The flood washed out some of these sediments and rain over the ensuing years eroded away additional lake-bottom sediments. Our LiDAR-based volumes represent the present basin, but some adjustments, such as for the modern double-track railroad bed, and dam slope have been taken into account so that the basin would be more similar to what existed in 1889. The present study also gives a new acreage value for the lake at spillway lip level (1,609 feet) of 374 acres, and defines the drop in elevation from the base of the dam (1,543 feet) to the Stone Bridge in Johnstown as 380 feet.

FIGURE 3: View of the former lake bed upstream of the dam. An erosional gully is carved in the lake-bottom sediments. The structure at left center includes remnant of the former control tower and stone culvert. Remains of hemlock pilings used to block the culvert are also visible in the middle of the breach on the left side, near a man standing beside the stream. Masonry covering part of the upstream side of the dam can be seen on the right. Figure courtesy of the Johnstown Area Heritage Association.

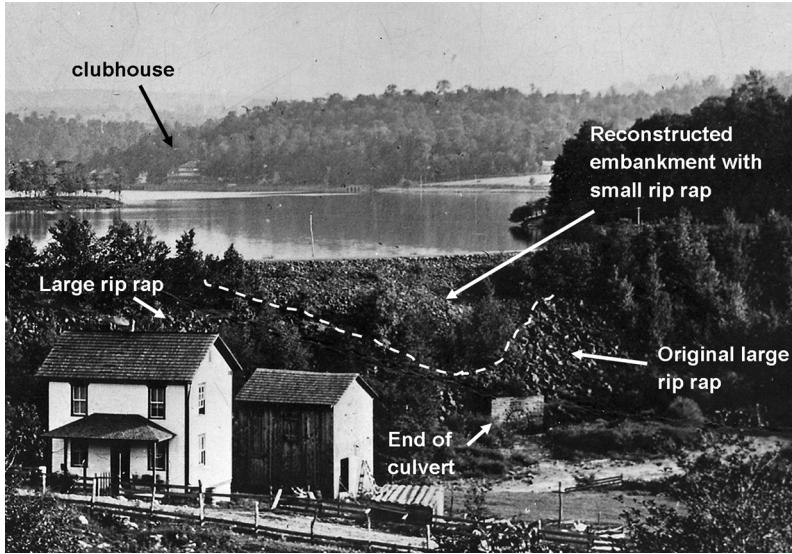
The reference to old bricks relates to waste from fire brickyards near South Fork.²⁴ Along with the old bricks, this waste contained a certain amount of plastic clay, which was used to manufacture bricks. When wetted, plastic clay has very low shear strength and was probably a major factor in the resultant catastrophic failure.²⁵ In addition, brick as fill material results in incomplete compaction, especially when there was no attempt to fully compact the fill. An important omission in the repaired dam was the puddled clay in the core of the dam that had originally been used to reduce the permeability of the upstream section of the dam. The absence of low-permeability puddled clay material meant that water saturation could extend further through the core of the dam, making it susceptible to piping and liquefaction. Furthermore, the downstream face of the dam was compromised by the failure to replace the very large rip-rap that originally armored it. Instead, the downstream face of the repaired section was covered by undersized rock (see fig. 4).

Of even greater concern was the fact that, since the new fill in the reconstructed dam was not properly compacted, there was a sag in the central portion of the embankment so that the freeboard (the height to which water could rise without overtopping the dam) above the spillway floor was further reduced. Estimates vary as to the amount of sag, but as measured by Davis it was at least two feet relative to the ends of the embankment two weeks after the flood.²⁶ As a result, water overtopped the dam in the center, which is the worst possible case for an earthen dam.

FIGURE 4: Pre-flood view looking upstream at the dam, as repaired by the SFHFC. Note the much smaller rip-rap of the repaired section. Figure courtesy of the Johnstown Area Heritage Association.
