THE SIGNIFICANCE OF PIKILLAKTA

ANDEAN CULTURE HISTORY

William T. Sanders

Occasional Papers in Anthropology No. 8, 1973

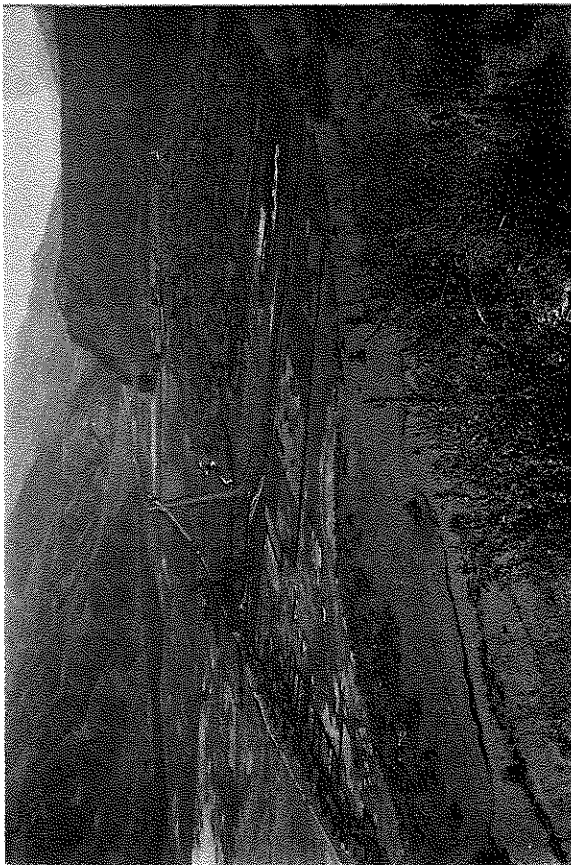
Plate 1	.413
a. General area of site-view to southwest	
b. Huatanay or Cuzco Valley from north edge of site. Village in midground is Huacarpay. Note walls of Inca Granary Complex on the small hill in midground right

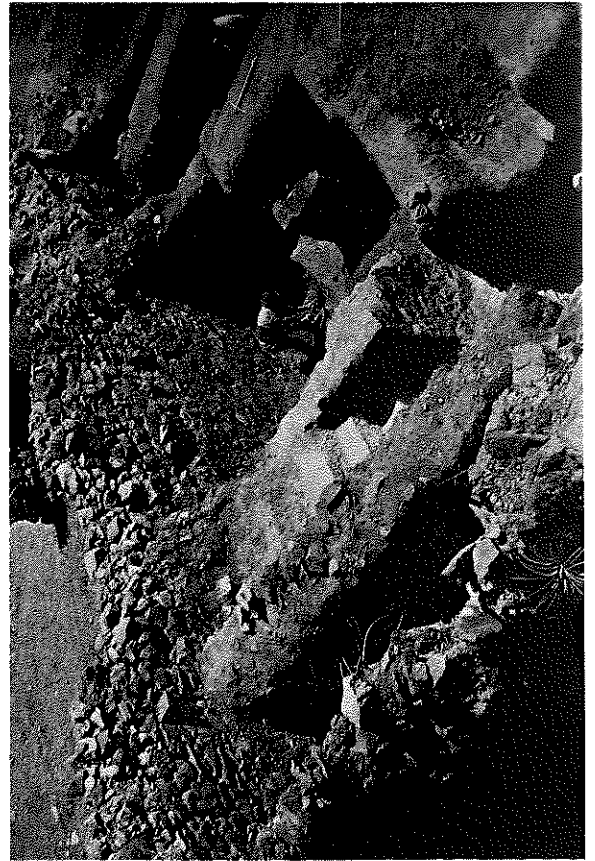
c. Unit I-Plaza A-General view of excavation looking southwest	
Plate 2	.415
a. General view of Great Plaza, Entry Terraces and in the distance the South Approach Avenue-view to south

Before excavation the building appeared as a small U shaped enclosure, with three walls on the north, east and south sides, and open to the west where it faced Plaza A. Traces of walls and distribution of debris suggested the presence of narrow corridors of the standard Pikillakta type on the east and north sides. The area that excavation later revealed as a patio and Rooms 2, 3 appeared as a completely levelled surface with no indications of rooms.

The excavation was initiated along the west side of the west wall of Room 1. This trench uncovered a beautifully preserved stairway of at least five steps (the upper section is destroyed). Following the excavation of the stairway, the doorway and the southern half of Room 1 were excavated to floor level. In all excavations the debris was removed in arbitrary levels. Following this, Room 2 was completely excavated to floor level. In the balance of the excavation narrow trenches were dug along walls to obtain data on the building plan. In some cases such probing trenches were only 50 centimeters deep. As a result of the excavations the plan in Figure 2 emerged.

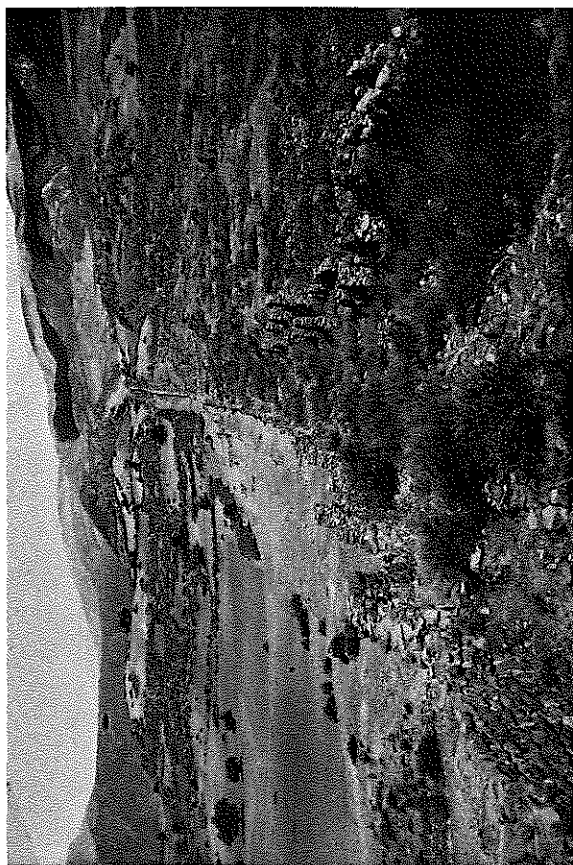
b. General view of Great Plaza, Entry Terraces view to north	
c. South Peripheral Street-view to east	
d. South Peripheral Street-view to west-note South Approach Avenue in midground	
Plate 3	.417

Great Plaza - Over half of Area 1 is composed of an enormous open space I am calling the Great Plaza. The surface is very uneven, with depressions and rock outcrops; little attempt was made, apparently, to regularize the terrain. The western edge was bordered by a massive wall with no definite entrance (sections of it, however, are completely eroded away). At the north it is bordered by 2 parallel rows of 4 Large Rectangular Buildings each. They are similar to such units in Area 2, but are somewhat larger and with a much lower ratio of roofed to open space than most of the latter. They have no definite doorways communicating with the plaza, Enclosure A or Avenue A (except possibly between Building 112 and the plaza but this is doubtful). There may be a flight of terraces running along the west wall of the plaza into Building 112-113.

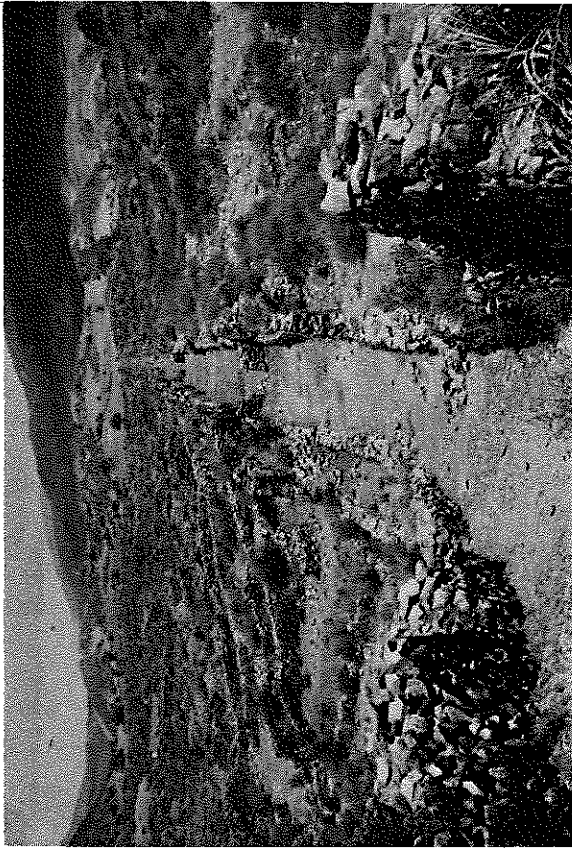
b. Avenue E-view to north	
c. Terraces at Entry Complex-view to north	
d. Terraces and Stairway of Entry Complex-view to east

Avenue E is a major north-south thoroughfare. It runs the entire length of the site, starting at the South Peripheral Street, and ending at 8th Street on the north end of the site. It has exits into 4th, 5th, 6th, and 7th Streets and is therefore, a key avenue for east-west traffic movement. The avenue varies from 3-4 m. in width and because of its length, straightness, and lack of obstructions, is the most imposing traffic artery on the site. It separates Areas 2 and 3, and was a major route to Plaza A and the Small Conjoined Room Complexes. At three places (at Structures 34, 38, 40), the width was reduced by constructing a cross wall with a narrow gateway. The gateway was presumably closed by a wooden door. The main purpose of these gateways would seem to be to control access to 4th Street - the main entrance to Plaza A from the east.

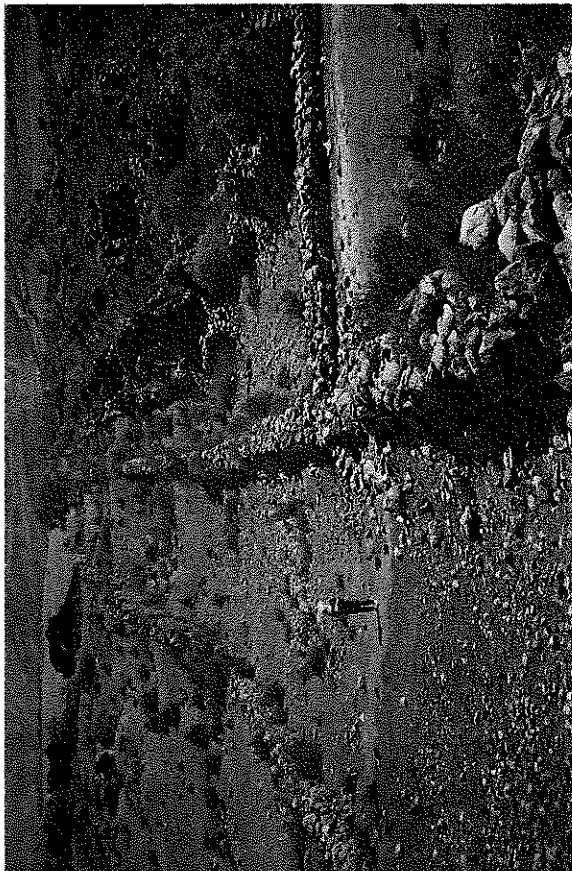
a. North Peripheral Street-view to east, in background left can be seen the walls of the North Approach Avenue. To the right is Small Conjoined Room Complex C with its Peripheral Street.

The North Peripheral Street is approximately 9 m. wide and runs west from a point of junction with the North Approach Avenue, to the northwest corner of the site where it makes a right angle turn, continues along the west edge of the site for 300 m. and dead ends. This west branch may not have had an external wall and possibly appeared as a terrace. The North Peripheral Street possibly communicated directly with Avenue A but this is uncertain since debris covers the evidence.
