By David Scofield, Director,
Meadowcroft Rockshelter and Historic Village

Rehabilitating the Pine Bank Covered Bridge

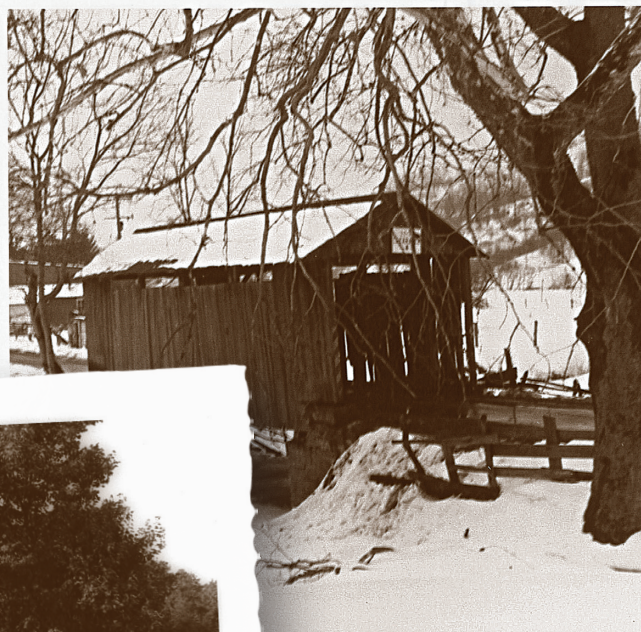
The Pine Bank Covered Bridge photographed by Albert Miller in 1961 at its original location.

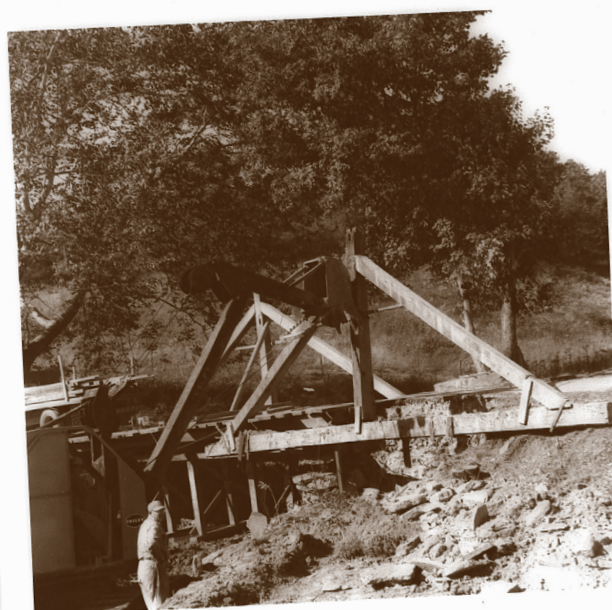
The dismantling of the Pine Bank Covered Bridge in 1962. The triangular truss is evident with the central "kingpost."

well over 10,000 covered bridges existed in America.² Today the Pine Bank Bridge is one of only 672 original covered bridges surviving.³ Even more remarkable is that the Pine Bank Bridge is one of only about 20 of the kingpost truss type covered bridges remaining in the nation.⁴ The kingpost truss is the simplest of the truss types and was used for short span bridges.

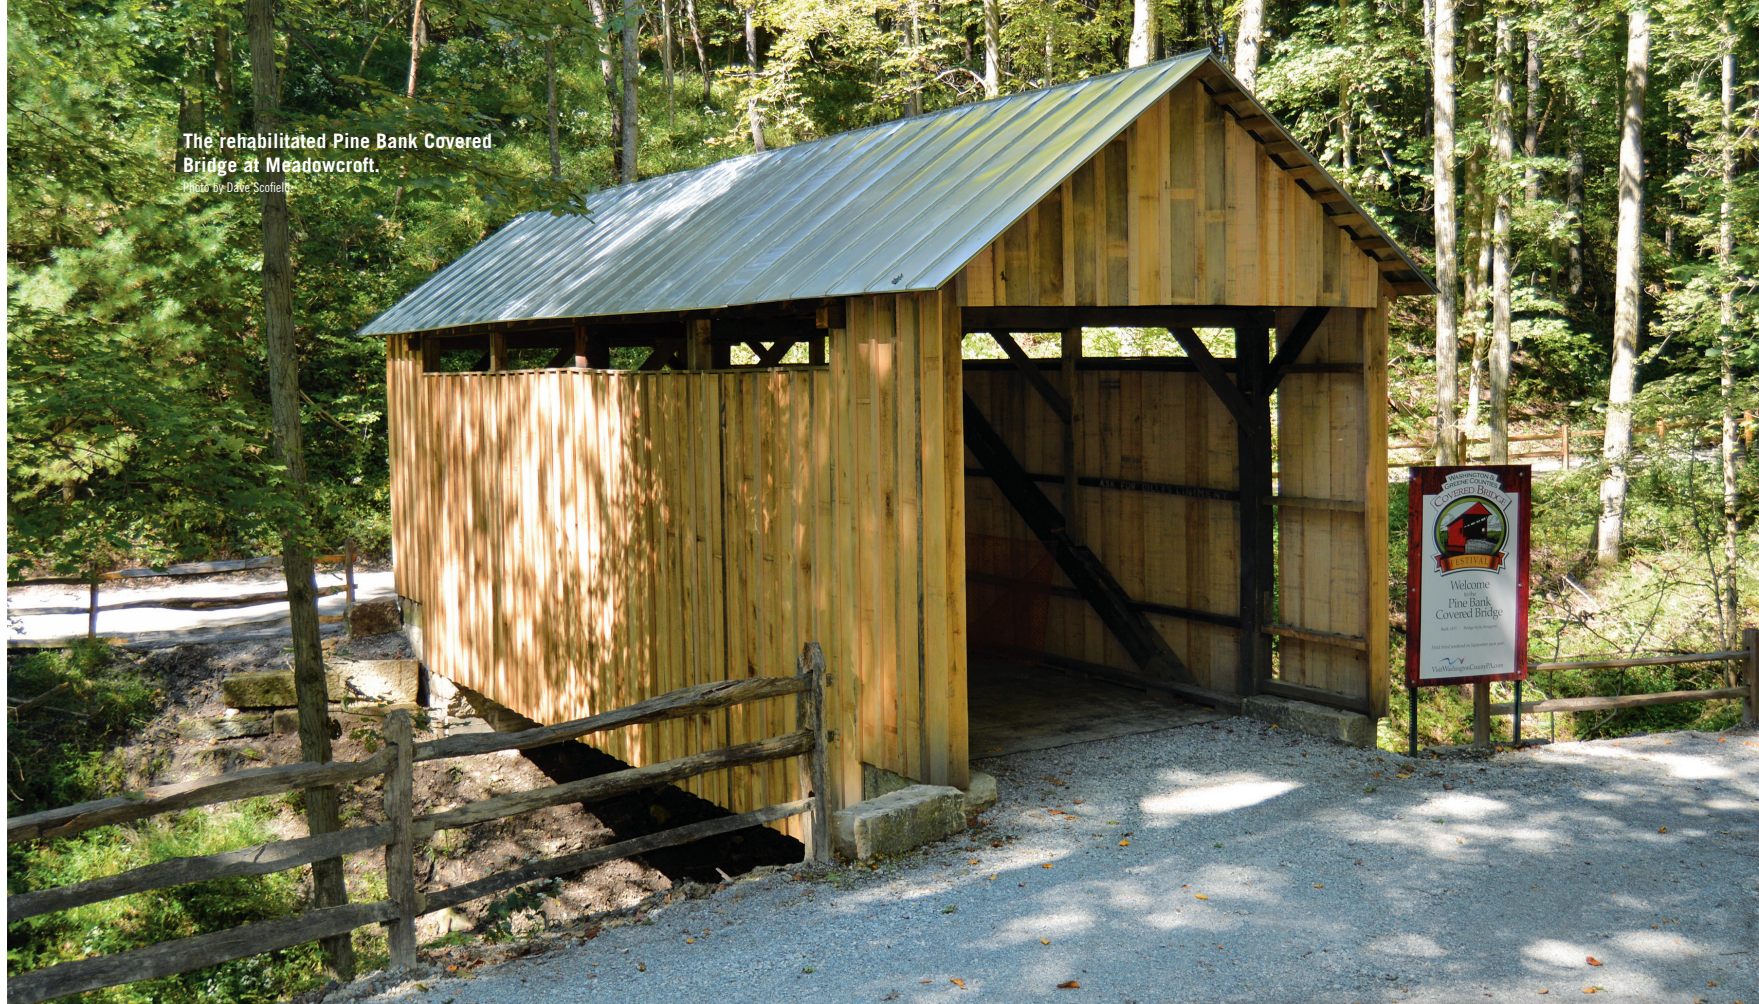
The rehabilitated Pine Bank Covered Bridge at Meadowcroft.

Timber-frame specialists from Fitzgerald's Heavy Timber Construction, Inc., dismantled the truss, spliced in new timber where decay was present, and then reassembled the bridge. In addition to repairing the truss, the project included several changes which would return the bridge more closely to its 19th century appearance. Support braces, which had been installed under the bridge in the 1980s, were removed. The roof was replaced with a period-appropriate standing-seam metal roof and the roof line was extended by four feet on both ends of the bridge. This was done to accommodate new vestibules since the originals had been removed when the bridge was relocated in 1962. Vestibules are walls that extend the length of the bridge beyond the trusses. They are designed to provide the trusses with additional protection from the weather. Finally, the oak board and batten

siding will remain unpainted as it was on most covered bridges in the 19th century. Now the newly rehabilitated bridge not only looks more like it did when it was originally built in 1871 but it is ready for another 145 years. ⚙️

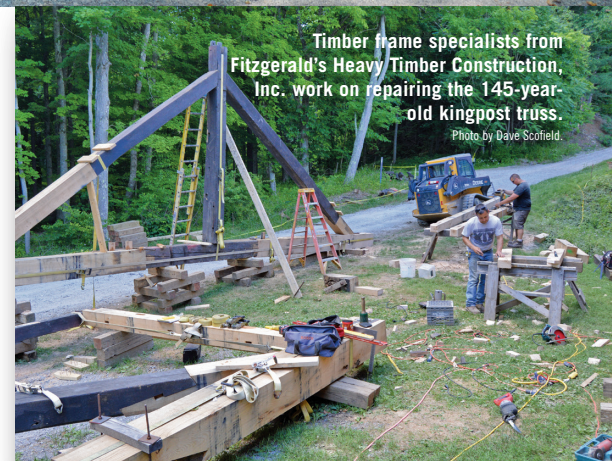
Timber frame specialists from Fitzgerald's Heavy Timber Construction, Inc. work on repairing the 145-year-old kingpost truss.

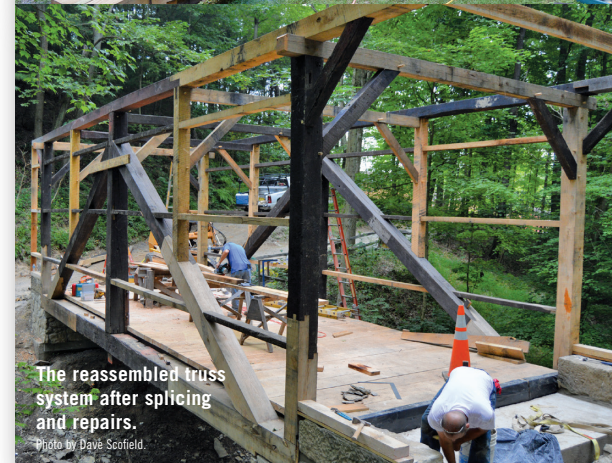
The reassembled truss system after splicing and repairs.
